# Draft Initial Environmental Examination (Main Report – Part 2 of 4)

Project Number: 52362-001  
April 2019

## BAN: Spectra Solar Power Project

Prepared by ERM India Private Limited for Spectra Solar Park Limited and the Asian Development Bank.

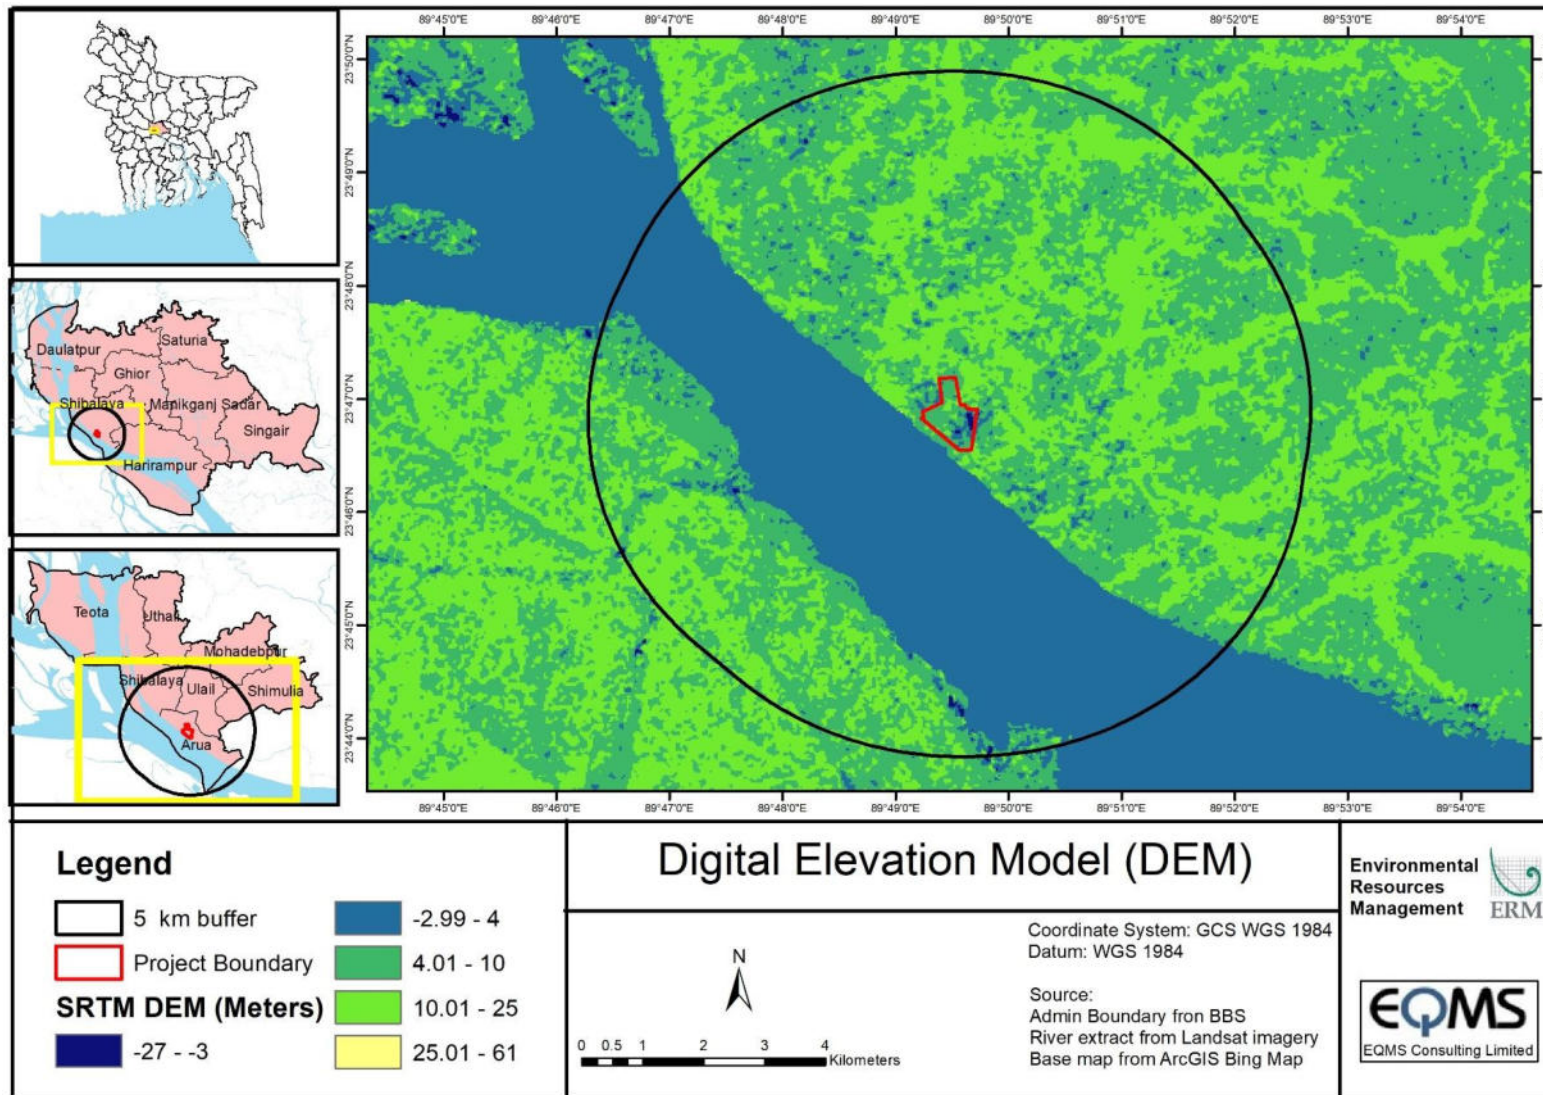
Figure 5.3 Digital Elevation Model of the Study Area

A digital elevation model (DEM) or 3-D representation of the terrain surface of the study area is shown in **Figure 5.3**. All the relevant information are extracted from the Shuttle Rader Topography Mission (SRTM) DEM only. All the processing was done in the ARC GIS 10.4.1 software. DEM shows that the topography of the 5 km study area is predominantly a medium terrain with maximum elevation in the western part of the study area. The ground elevation was observed to vary from 12 – 16 m in isolated patches within the study area, followed by areas with elevation ranging between 08 – 12m and 4 – 8 m amsl. Continuous gradient was not observed in the study area. Most of the Site area falls in the 4 – 10 m amsl elevation. East-southeast portion of the Site being the lowest point varying between sub-zero – 4 m amsl.

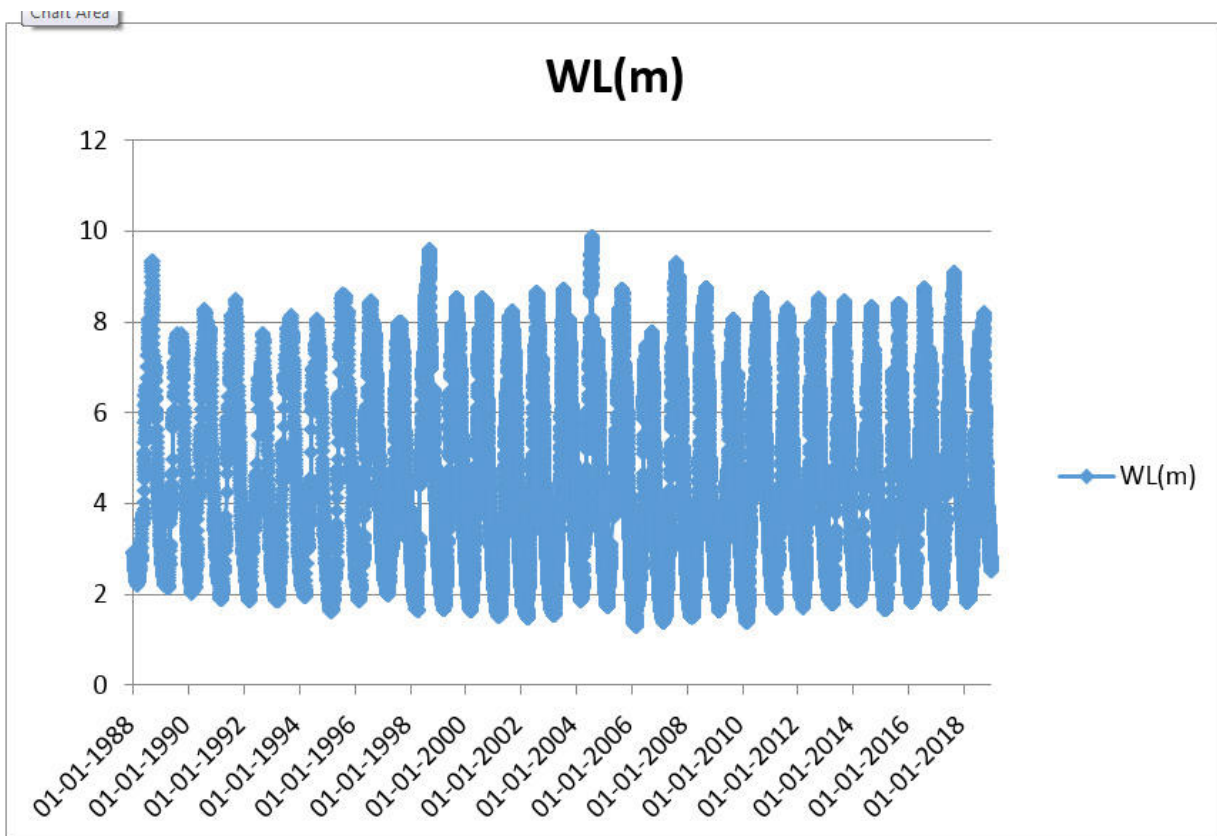
**Figure 5.9 30 years water level data of Baruria Transit**

Figure 5.9 shows the 30 years water level data of Baruria Transit (Padma River and Ichamoti River).

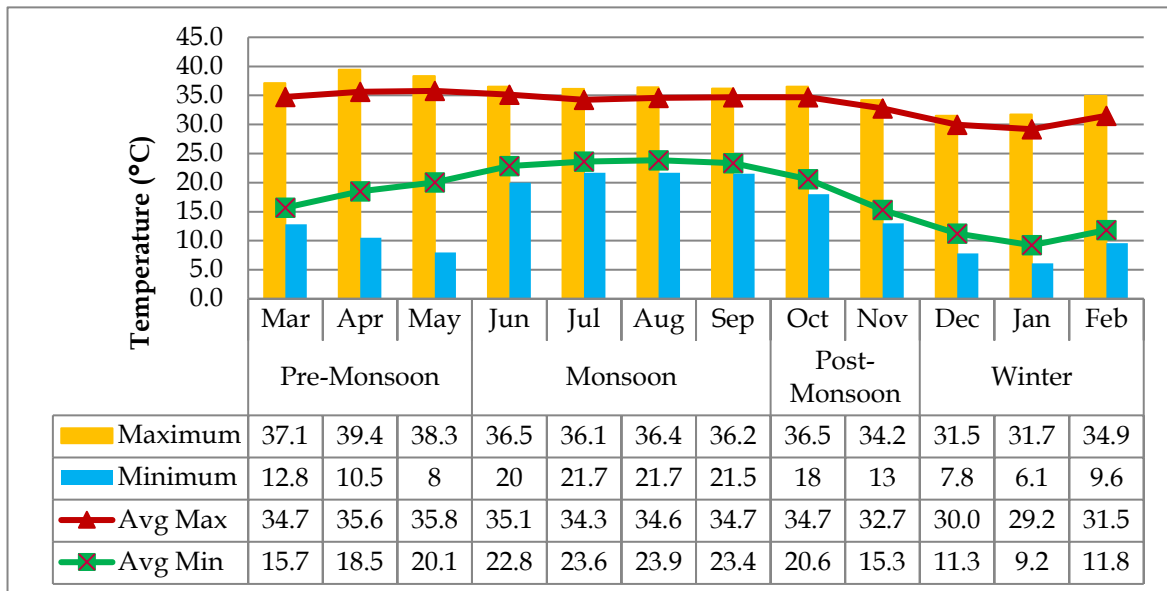
**Figure 5.13 Monthly Maximum, Minimum and Average Temperatures (1987-2018)**

The maximum, minimum and average temperatures recorded at the Tangail weather station which is 50km far from the project site are presented below in **Figure 5.13**. The data analysis of 30 years (1987-2018) shows that monthly maximum temperature varies from 33.0°C to 39.0°C whereas monthly minimum temperature varies from 6.1°C to 21.7°C.
